**Docket No. 217 – Development and Management Plan Inspection**

**Norwalk Substation**

**Date:** May 17, 2006

### Plumtree Substation

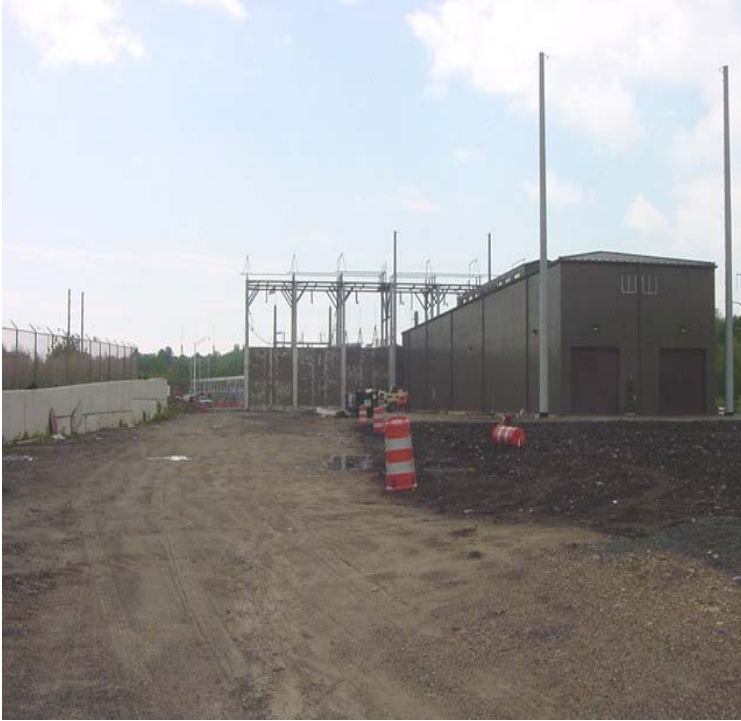
Norwalk Substation: Photo on the left shows an overall view of the yard with the recently spread and graded topsoil. Photo on the right shows the high flow of the Norwalk River near the turning structure. 5/17/06.

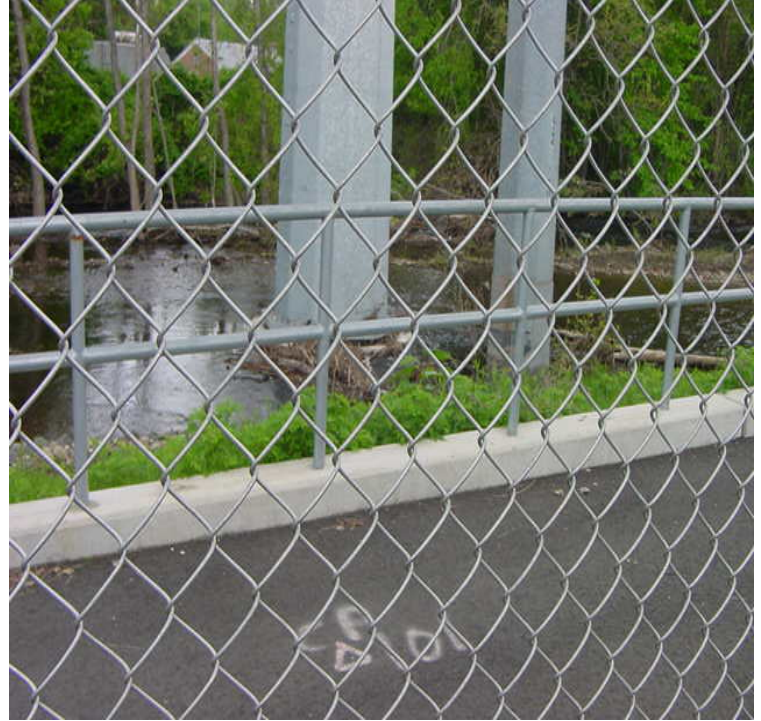
Inland Wetland and Watercourse encroachment and mitigation	- The overflow channel and natural overflow area had a high level of flow due to the rains this week. 5/17/06.  - Vegetation continues to grow well along the original overflow	- The slope near the turning structure will be checked when water recedes. 5/17/06  - None at this time. 5/17/06.	-N/A  -N/A.

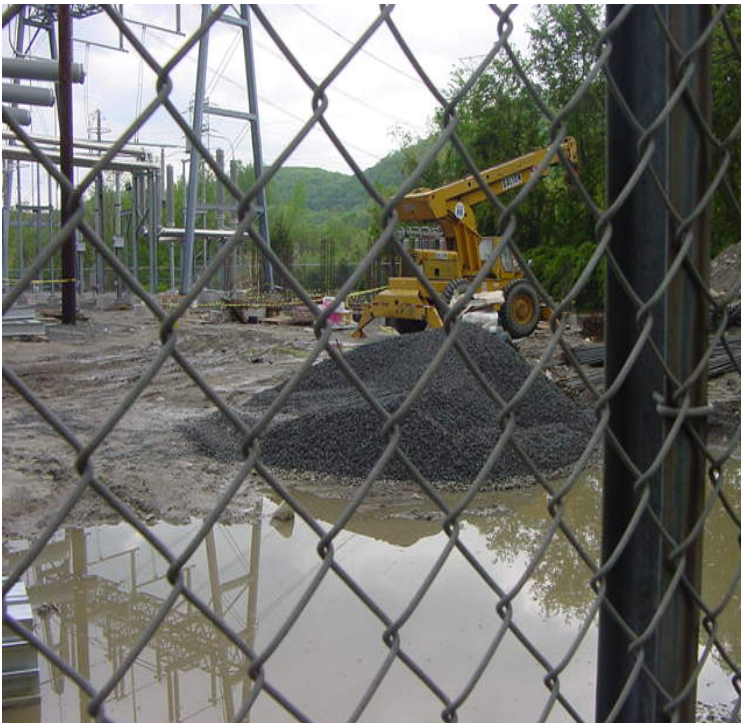
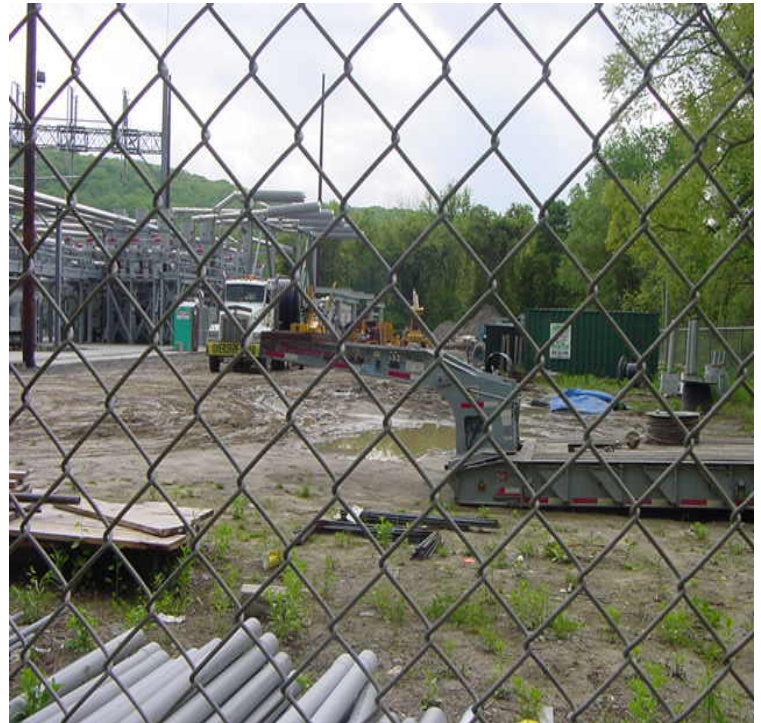
Plumtree Substation: Both photos show the ongoing foundation work and resulting stockpiles within the yard. The yard remains contained. 5/17/06.
